SUPERSONIC RAIN AND SAND EROSION RESEARCH:
CHARACTERIZATION AND DEVELOPMENT OF
EROSION RESISTANT MATERIALS

TEXTRON'S BELL AEROSPACE COMPANY

TECHNICAL REPORT AFML-TR-72-85

MAY 1972

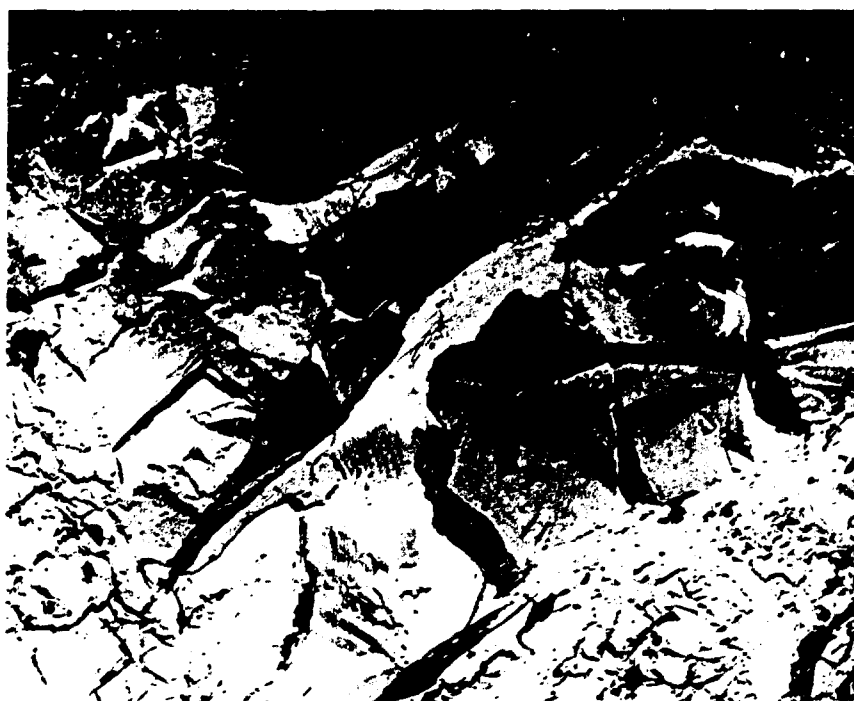
FIGURE 20. Electron micrograph-7000X view of fractured boride coating after 50 minutes exposure to sand particle impact at 880 ft/sec.

As noted in Table VIII the boride coating lost 100 milligrams in fifty minutes as compared to the other coatings and titanium of approximately 10 minutes. Figure 17 shows graphically the resistance to erosion compared to the other coatings. Figure 18(a) shows only slight pitting of the specimens after 20 minutes of test and Figure 18(b) exhibits the relatively small amount of erosion after 50 minutes of test. Figure 19 is a 650X scanning electron photomicrograph of the Chromalloy boride coating before and after testing in sand. Figure 19(b) shows how the boride coating is scoured by the impacting sand particles. Figure 20 is an electron photomicrograph of the boride coating at 1000X showing how the boride coating has fractured due to solid particle impact.

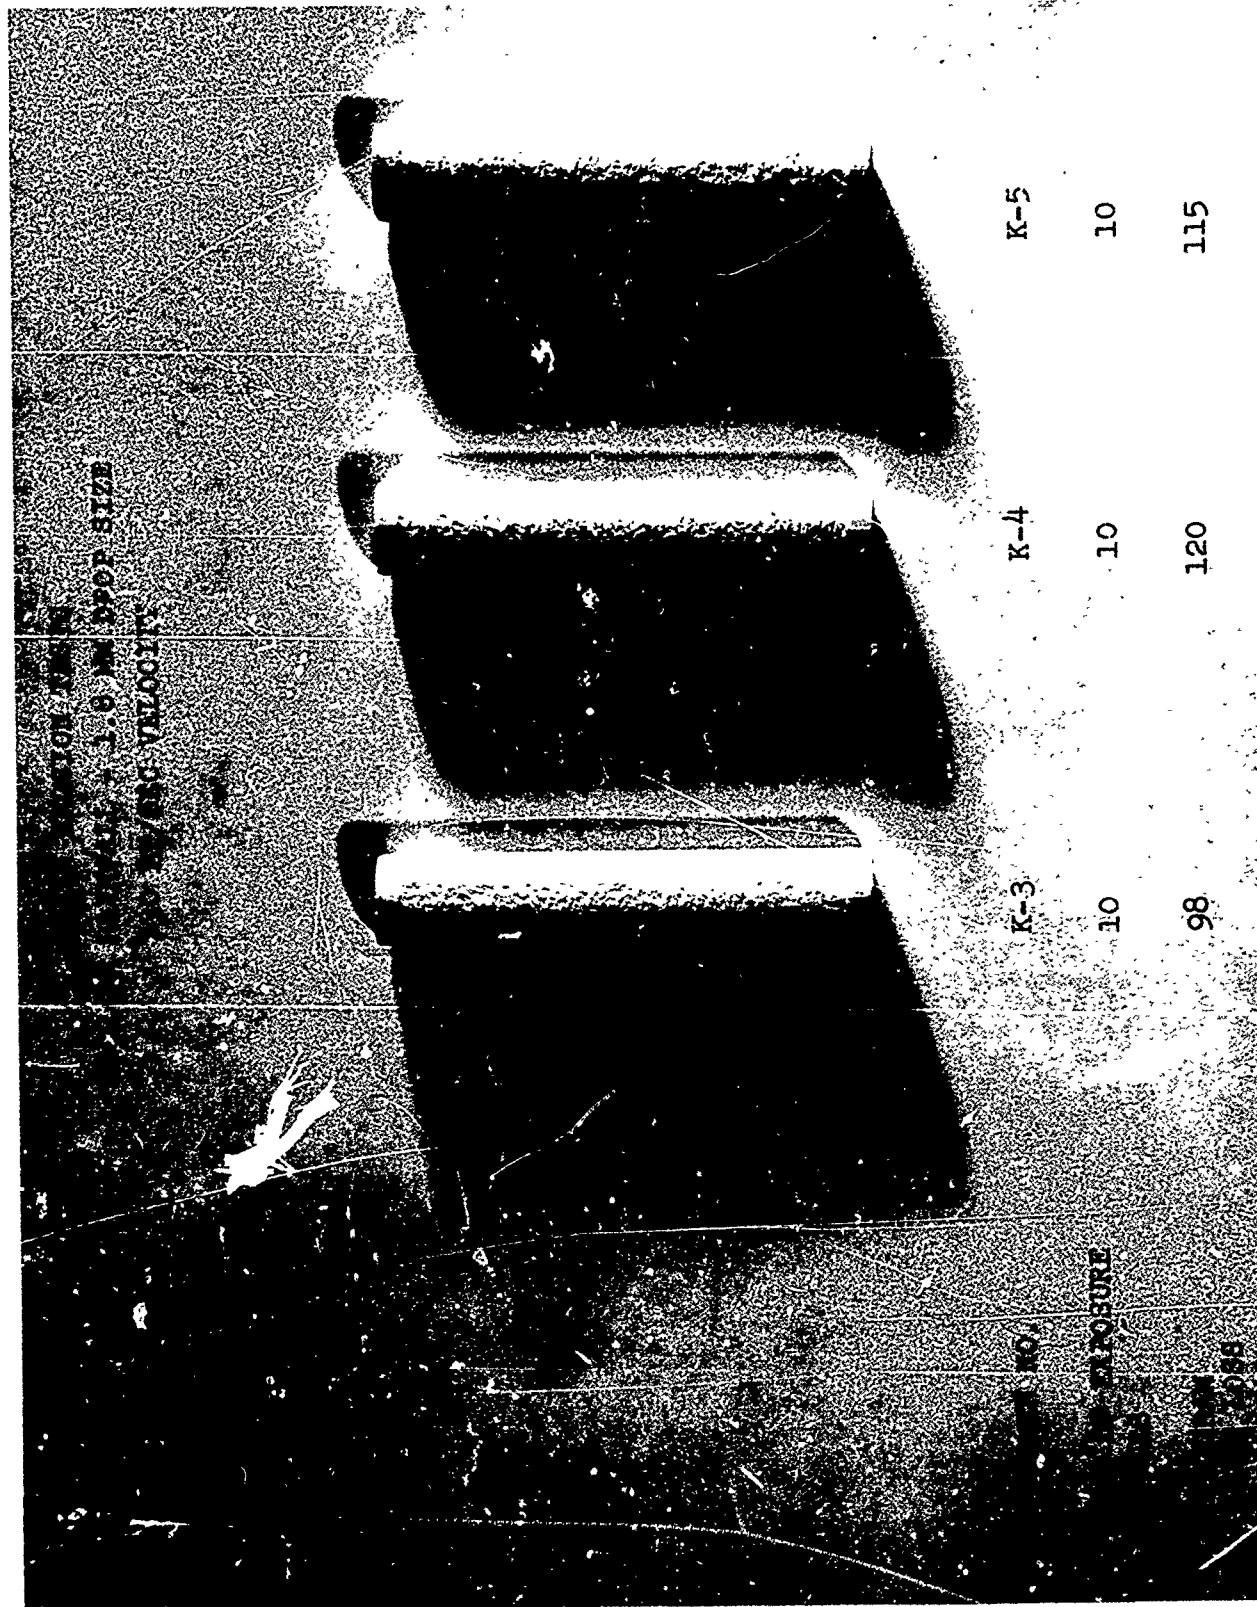
Figure 48 Erosion of Acrylic-Polyvinylchloride Plastic

Kydex a copolymer of acrylic and polyvinyl chloride which had a slightly higher impact strength than polycarbonate was tested at 720 and 1130 ft/sec. As noted in Table XXV and XXVI the specimens lost approximately 100 milligrams in ten minutes at 720 ft/sec and in two minutes at 1130 ft/sec. The type of erosion experienced is shown in Figures 48 and 49.

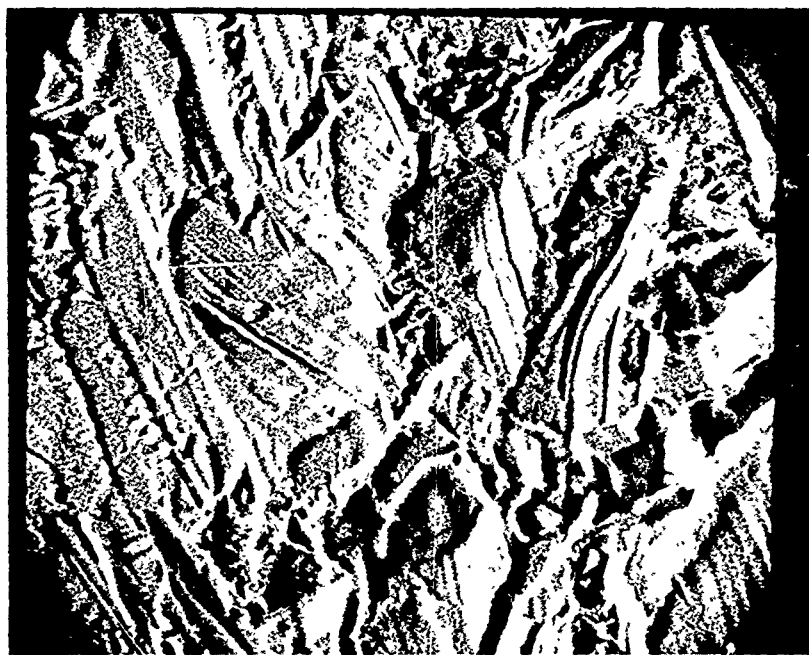
Sand erosion of ductile material at oblique incidence. The surface of a Ti-6Al-4V alloy sample exposed to sand erosion at ~ 900 ft/sec and an angle of incidence near 35° . The eroding sand was a specification MIL-E-5007-C mixture. Scanning electron micrograph 1300X.

Figure 68. Micrograph of Sand Erosion of Titanium Alloy

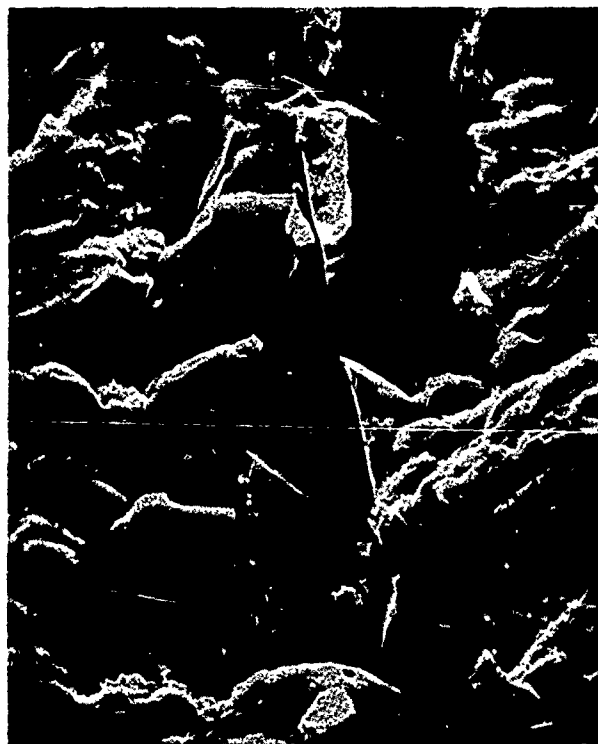
Figure 74. View of Fractured Fiber of Boron in Aluminum Matrix After
1-Minute Exposure to Sand Impact

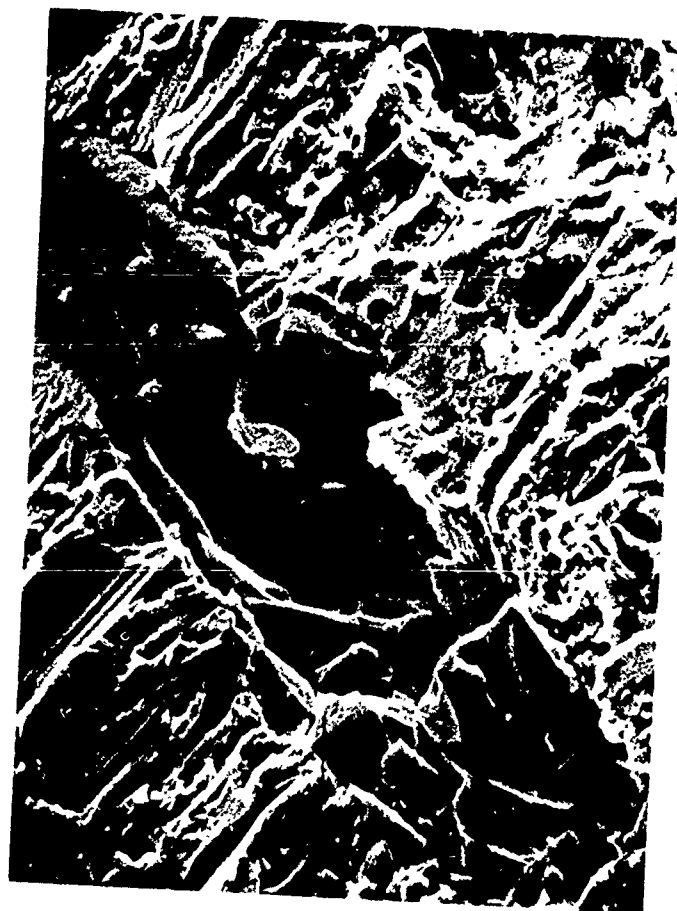
Figure 75. Scanning Electron Micrograph at 400X Showing Void in Surface of Boron-aluminum Composite

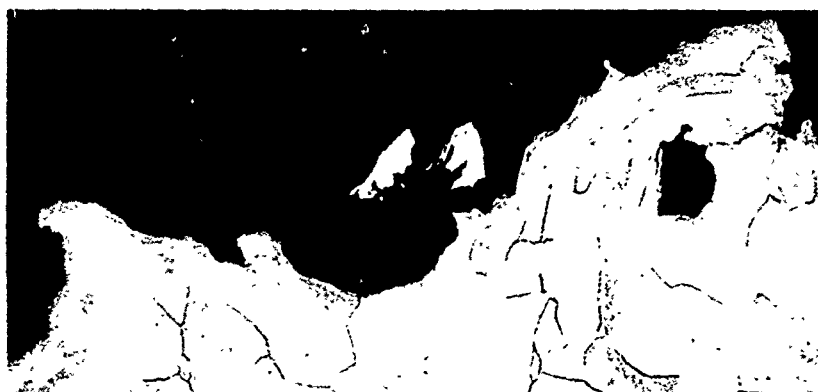
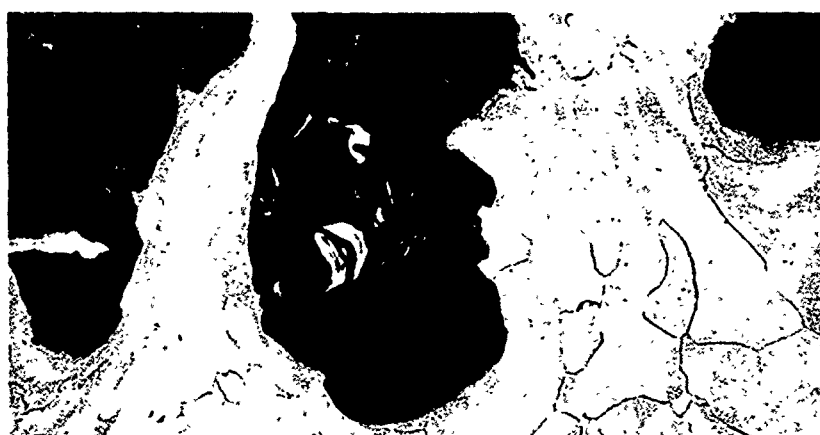
Figure 77. Micrographs of Erosion Damage on Etched Nickel Sample

The mechanism of erosion of pure nickel is illustrated in Figures 66 and 77. Figure 66a shows the surface of a sample exposed at 1120 ft/sec for 10 minutes. A few isolated surface pits are visible. Figure 66b shows the surface of a sample exposed for 40 minutes. The pits have increased in depth and number, and the surface has taken on an appearance generally similar to that of aluminum alloys which have begun to erode severely. The rate of erosion accelerates markedly over this time interval, as can be seen from Figure 76. Figure 66c shows a cross section of the nickel sample after 40 minutes exposure. The ductile nature of the damage process is evident in this cross section. If these pits are compared to those typically found in aluminum alloys (8) they are seen to be somewhat shallower and broader.

Figure 77a shows micrographs of etched cross sections of the 40-minute nickel sample. The severe ductile flow which occurs as the nickel samples are eroded is evident in these micrographs. Surface features like those in the

micrograph of Figure 77b seem to indicate that some material is removed from the lips of erosion pits through shear flow. Figures 77a and 77c illustrate the process of pit accretion as ductile pit growth occurs.

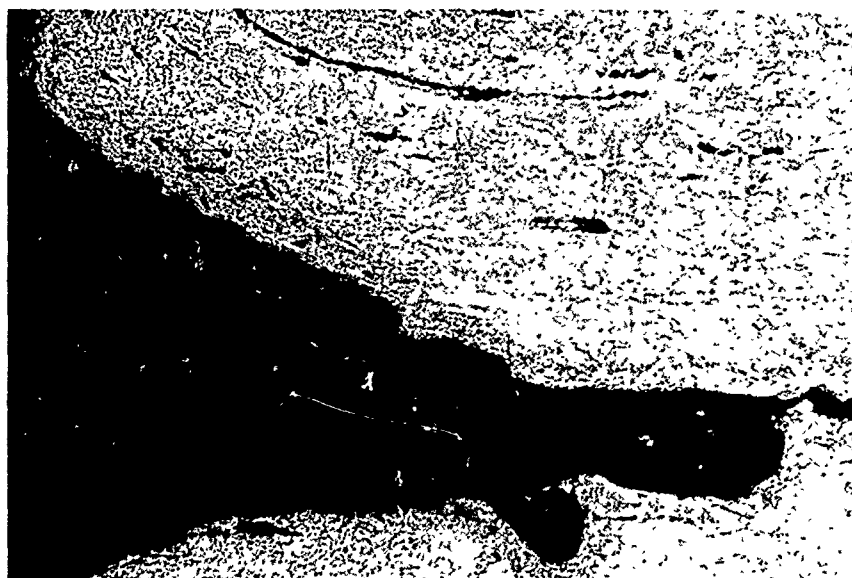
(a) SURFACE PIT, AT 250X

(b) PIT AFTER EROSIVE ATTACK 400X

Figure 80. Pits in Surface of 403 Stainless Steel Exposed at 1120 ft/sec for 45 Minutes

Reference to Figures 80a and 80b shows that portions of the 403 steel surface somewhat removed from these planar flaws are not seriously eroded even after 45 minutes exposure at Mach 1.0. It seems clear from this evidence that 403 stainless steel samples prepared to have unflawed, homogeneous surfaces would have substantially greater erosion resistance.

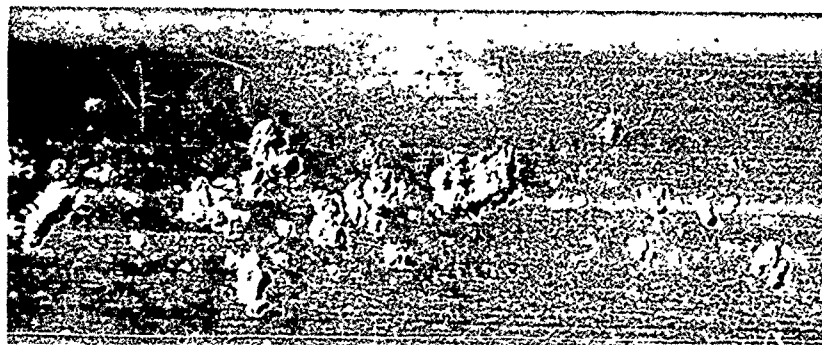
(a) AFTER 75 MIN. EXPOSURE

(b) AFTER 105 MIN. EXPOSURE

(c) AFTER 135 MIN. EXPOSURE

Figure 83. Erosion of Ti-6Al-4V at 1120 ft/sec - 4X

The overall appearance of the Ti-6Al-4V alloy samples exposed to rain at 1120 ft/sec is shown in Figure 81. The eroded surfaces of three of these samples are shown in Figure 83 at higher magnification. An additional titanium specimen was run for an exposure time of 30 minutes in order to observe the early development of the erosion damage. The condition of the surface is shown in Figure 82. The small pits developing on this specimen can also be identified on the specimens shown in Figure 83; however, the sequence of photographs in Figure 83 indicates that the very small pits develop into shallow, flat-bottomed pits. On further exposure the number and the mean lateral size of the broad, shallow pits increase. On this scale the pits appear to extend laterally without deepening appreciably.

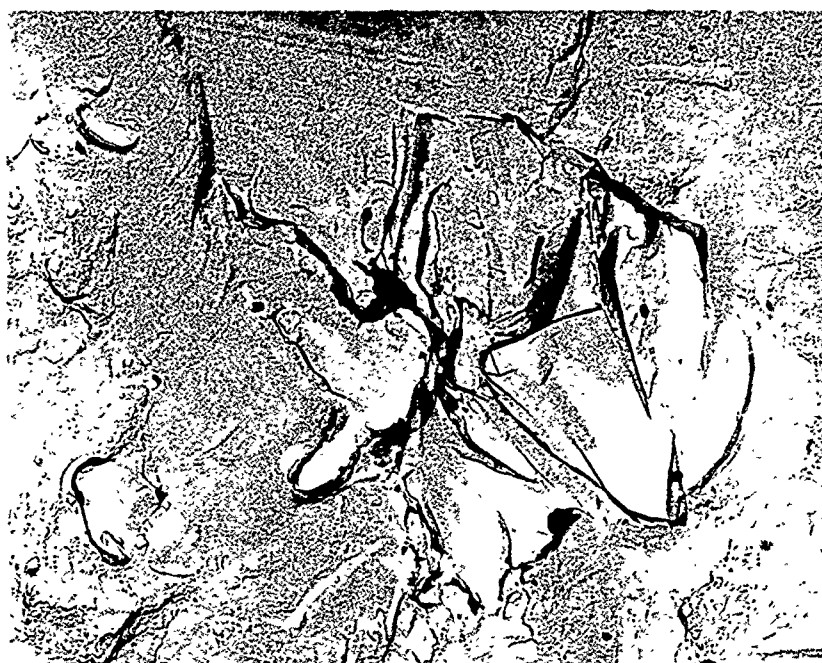
FIGURE 85. Localized cracking at precipitates on surface of Ti-6Al-4V - 3000X

The lightly eroded surface areas on the specimen with a 30 minute exposure time were found to consist of shallow, ductile indentations generally under one mil in diameter and a moderate density of localized cracking (estimated to be on the order of one thousand cracked zones per square inch). The general form of these cracked regions are shown in Figures 84-85. The existence of these regions indicates the presence of brittle precipitates at or near the surface.

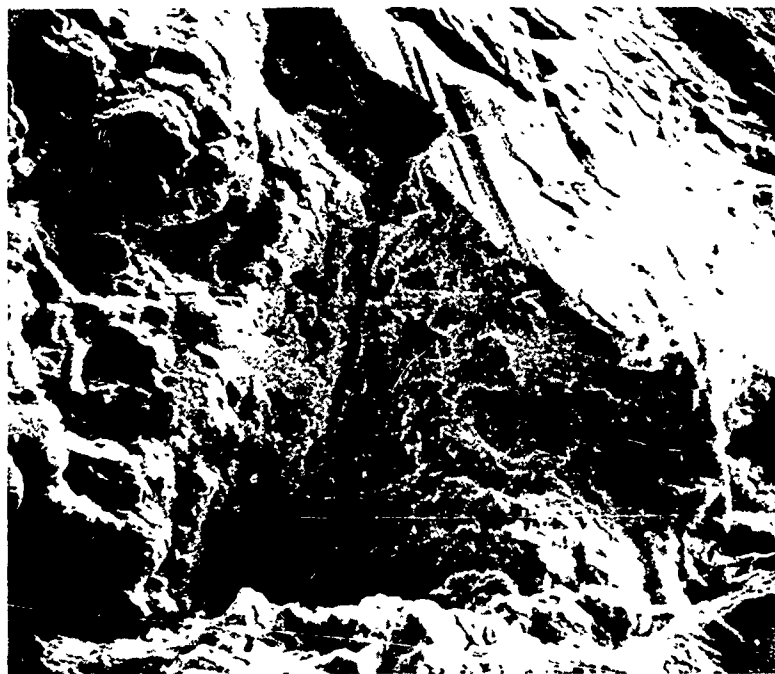
FIGURE 87 Scanning electron micrograph showing detail of small pit in Ti-6Al-4V - 650X

The micrographs in Figures 86 and 87 show the details of pits which are approximately 3 to 4 mils in diameter. Cracks are clearly visible along the walls of these pits which tends to support the cracking and fragmentation mechanism.

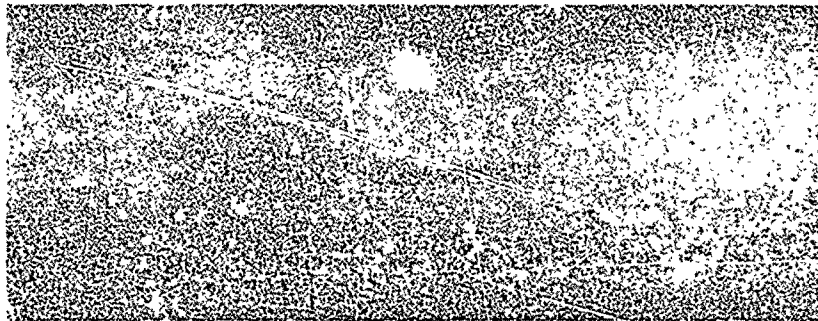
(a) Polyurethane W-121 after 9-minute exposure - 4X

(b) Polyurethane W-612 after 6-minute exposure - 4X

(c) Polyurethane W-134 after 2-minute exposure - 4X

FIGURE 96 Eroded surfaces of cast urethane in 1 in/hr
rainfall at 730 ft/sec.

The Winthane #612 was eroded for a total of 6 minutes, the #121 for 9 minutes, and a specimen of #134 used in previous tests on the polyurethanes was eroded for only 2 minutes. The extent of the damage at these exposure times is shown in Figure 96. Comparison of Figure 96 with Figures 49-51 provides some idea of the limited amount of damage considered in these investigations. Visual inspection of the lightly eroded surfaces shows very little evidence of removal of pieces of the surface for the #612; the surface still appears relatively smooth. The surface of the #121 is beginning to exhibit some degree of coarseness with a few pieces of material which have been partially freed from the surface clearly

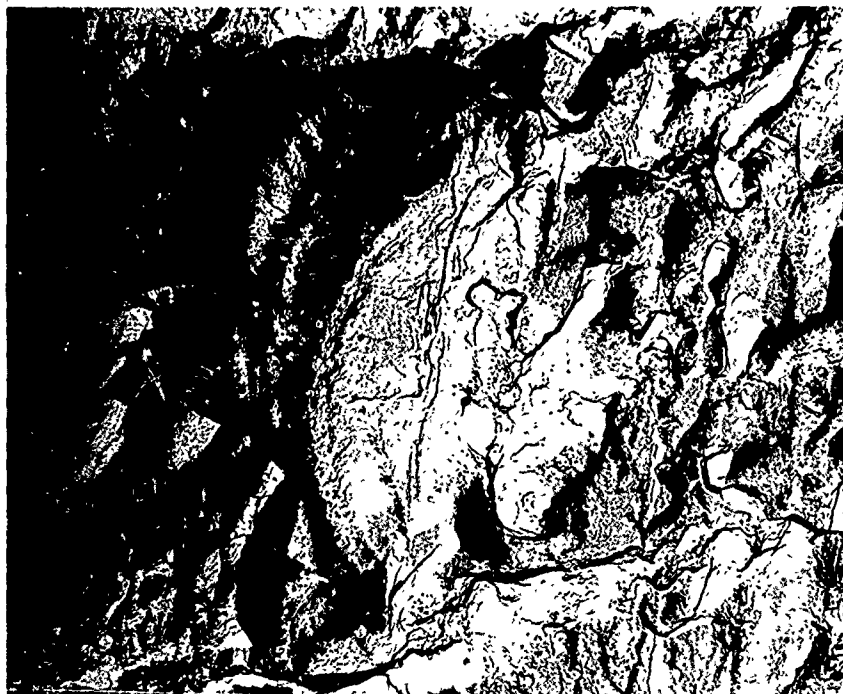
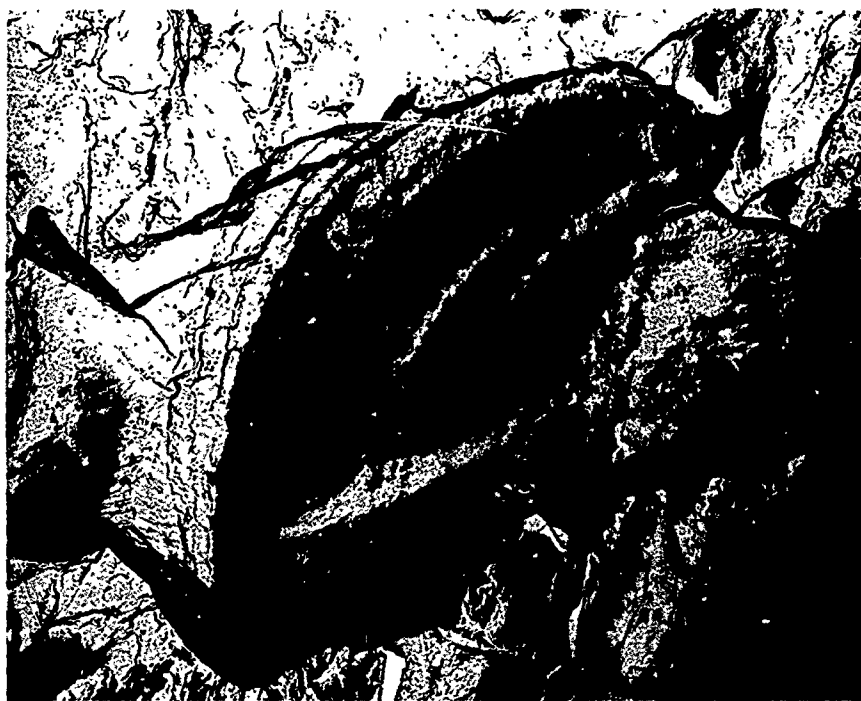
FIGURE 97. Transmission electron micrographs showing the initiation of pitting in polyurethane W121 after an exposure time of 5 minutes. 3000X.

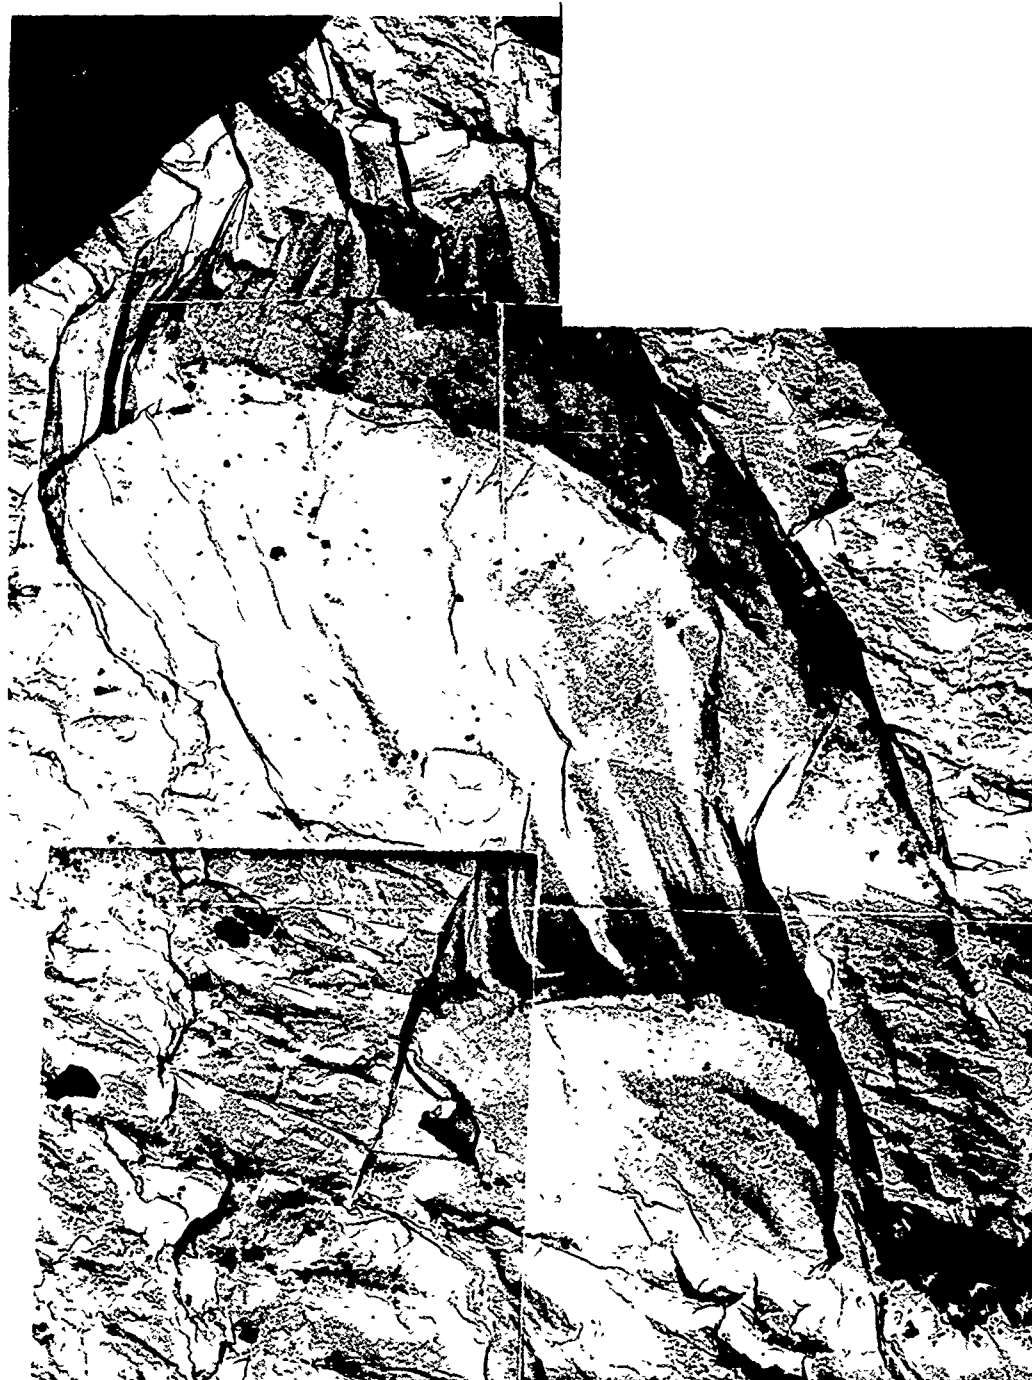
FIGURE 100. Scalloped fracture surfaces in polyurethane W121 after an exposure time of 5 minutes. (Shadowed surface replica - 2000X).

The process described above results in the scalloped configuration shown in Figure 100, which is a surface replica of one of the regions where small pits of this type can be seen and in the scanning electron

micrographs (Figure 101) taken at a later stage of the erosion process. According to the reasoning given above, the pits shown in Figure 100 took three or four successive impacts to produce. They are very shallow and a negligible amount of material has been removed. The large pit in Figure 101b required at least fifteen successive droplet impacts. Tearing of material around the rim of the pits is evident, as well as the remnants of the hinged area which intersects the smaller pit in the lower right-hand corner of the figure. The scalloped appearance shows where the crack stopped and was subsequently extended. The dark lines parallel to the front of the propagating crack are the result of the change in the speed of propagation as the applied force is reduced to zero. Figure 102 shows the same fracture surfaces in Winthane #121. The conchoidal features are the predominant mode of material removal from the surface of these elastomers.
